Inspection Report

This inspection report prepared specifically for:

Jane Doe
987 Main St
Massillon, OH 44646

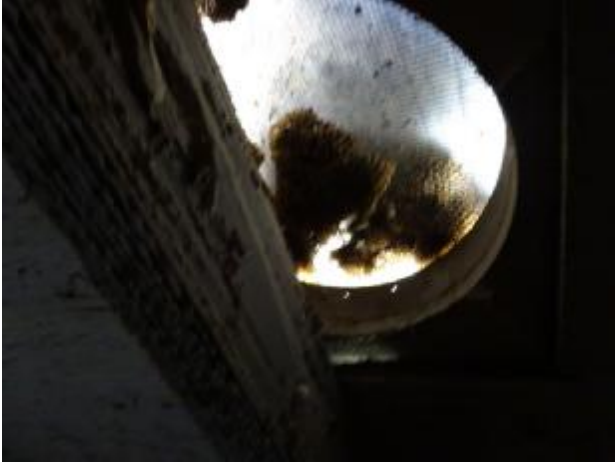
#R1

- 19
 1. **SAFETY HAZARD.** Wasp nest in roof vent above garage. Recommend reputable contractor to remove nest. (see photo 1).

Wasp nest in roof vent

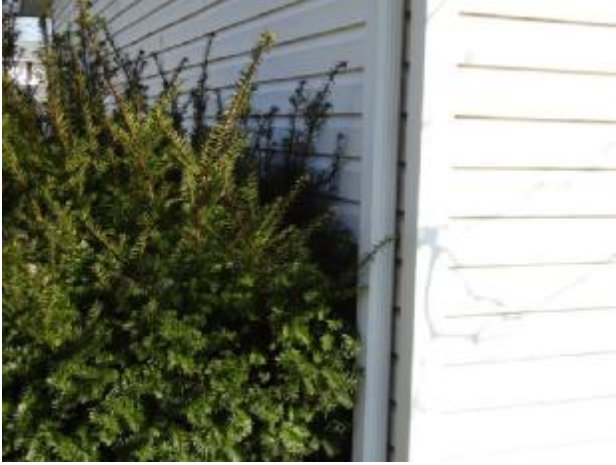
#GD1

1. Bushes growing against house. Recommend trimming to avoid possible mold growth and or pest infestation. (see photo 1).

Bushes against house

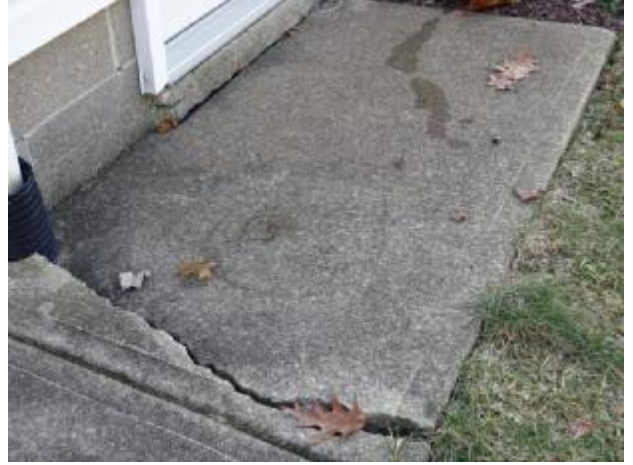
#GD2

2. Walkway by garage entry door is sinking and sloped towards house. Recommend reputable contractor. (see photo 2).

Slab by garage door sunk

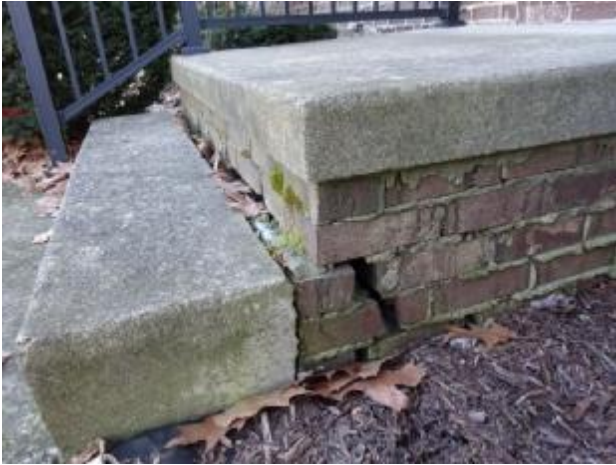
#GD3

3. Bottom step on front porch is separated from landing. Recommend reputable contractor. (see photo 3).

Step on front stoop separated

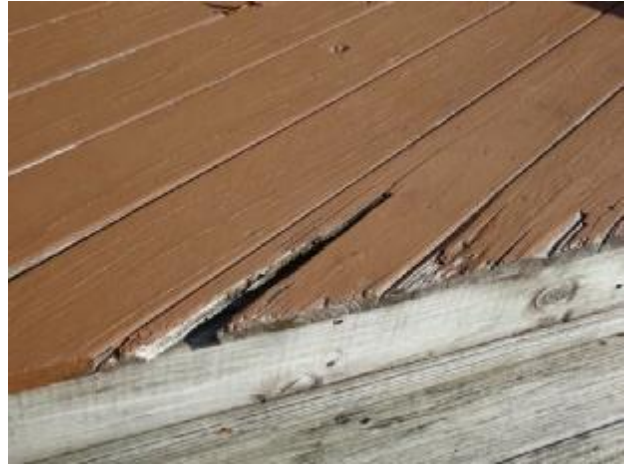
#GD4

4. Deck boards on floor of deck are deteriorating. Recommend reputable contractor. (see photo 4).

Deck floorboards rotted

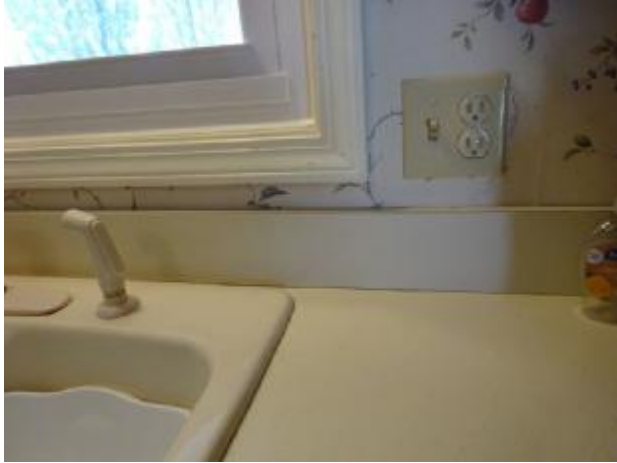
#K1

26
 1. **SAFETY HAZARD.** Outlets by kitchen sink are not GFCI. Recommend reputable licensed electrical contractor. (see photos 1,2).

No GFCI by sink

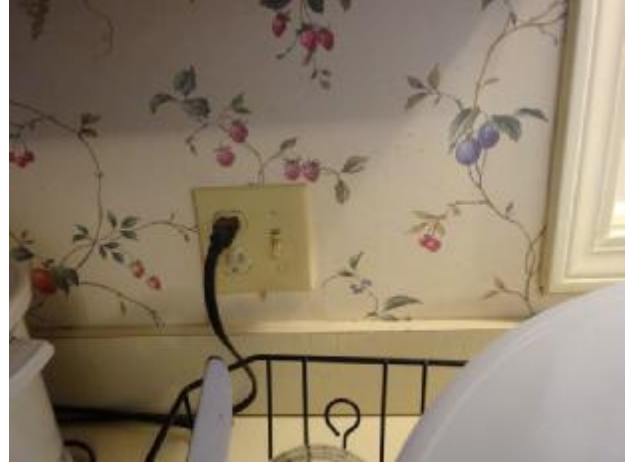
#K2

No GFCI by sink

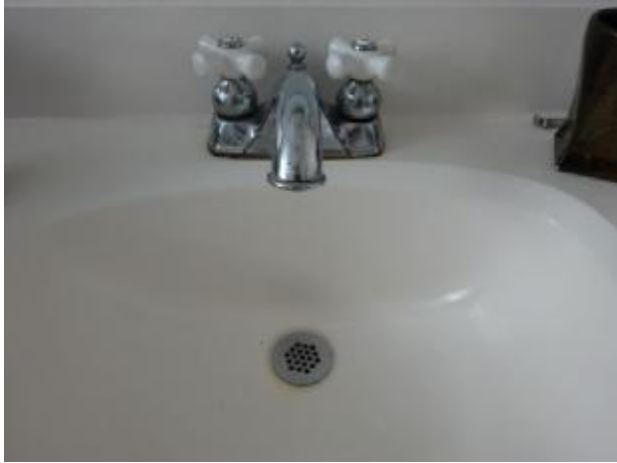
#B1

1. Missing drain stopper in sink in downstairs bathroom. Recommend install. (see photo 1).

No stopper in downstairs bathroom sink

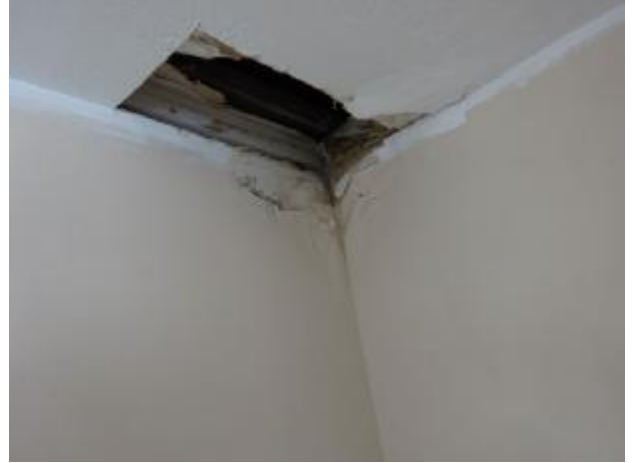
#B2

2. Prior water damage in ceiling area of downstairs bathroom. This is due to toilet overflowing. Recommend reputable contractor. (see photo 2).

Water damage and missing vent in bathroom

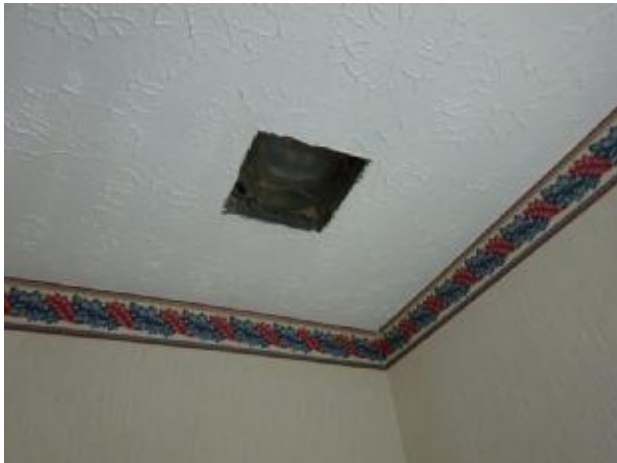
#B3

3. Missing vent cover for bathroom exhaust fan in master bathroom. Recommend install. (see photo 3).
4. Toilet in main bathroom is loose. Recommend reputable licensed plumbing contractor.
5. Missing heat vent in ceiling of downstairs bathroom. Recommend install. (see photo 2).

Missing vent cover in bathroom ceiling

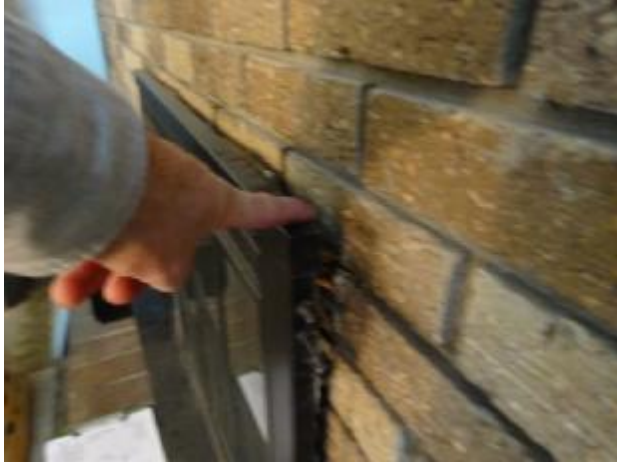
#IR1

1. Fireplace door is loose. Recommend reputable contractor. (see photo 1).
2. Missing cold air vent cover in kids bedroom. Recommend install. (see photo 2).

Loose fireplace door

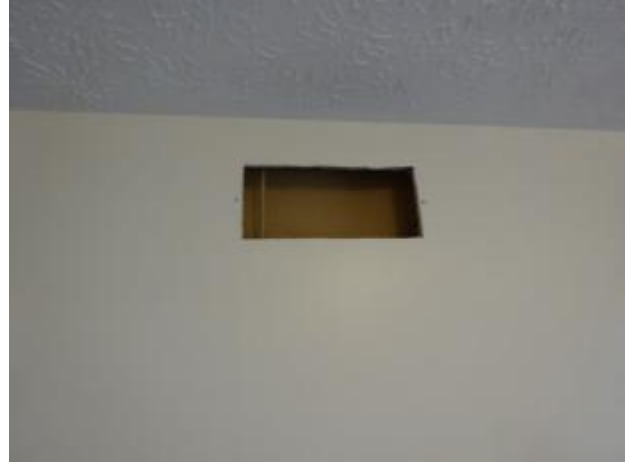
#IR2

Missing vent in bedroom wall

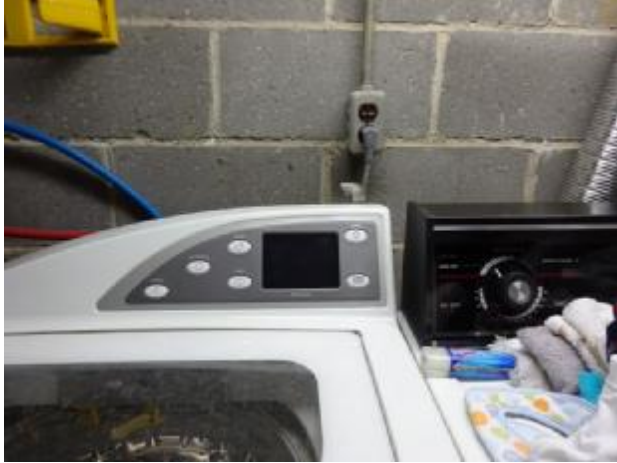
#F1

1. **SAFETY HAZARD.** Outlets on wall by washer area are not GFCI. Recommend reputable licensed electrical contractor. (see photos 1,2).
2. **SAFETY HAZARD.** Exposed wire in ceiling area of tool room should be in junction box. Recommend reputable licensed electrical contractor. (see photo 3).

No GFCI outlet by washer

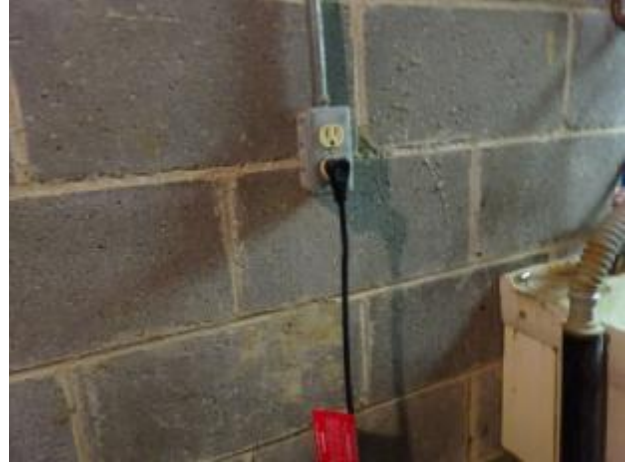
#F2

No GFCI outlet by sink

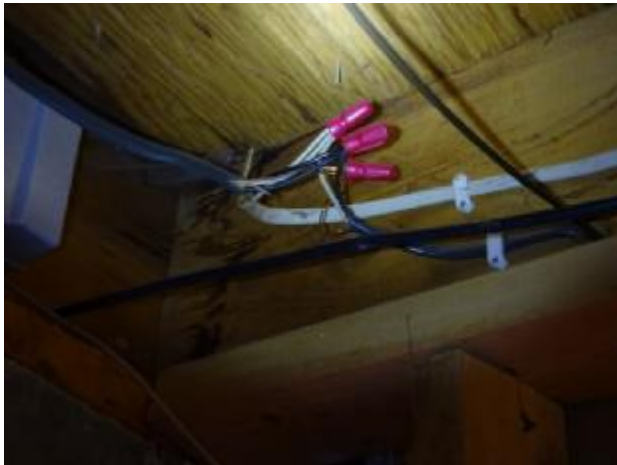
#F3

Exposed wire junction
